December 30, 2013 - Installed *HydroFLOW* 120i with winter protection (0° F / -18° C)

Installation - October 17, 2013

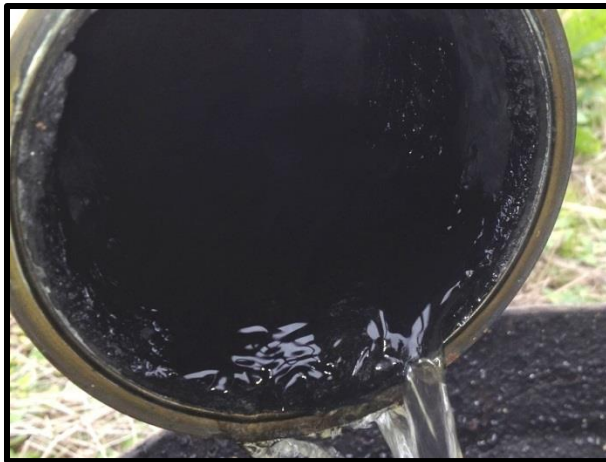
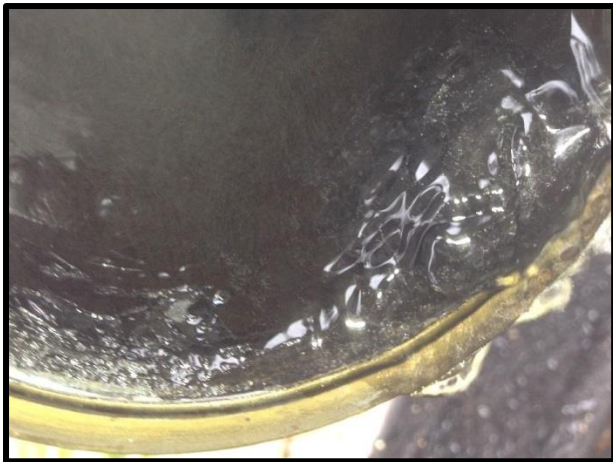
Baseline - Hard scale of roughly 1/2" along the inside of the pipe. The scale is dark because it is a mix of iron (predominantly), magnesium, calcium carbonate, silicon and other minerals.

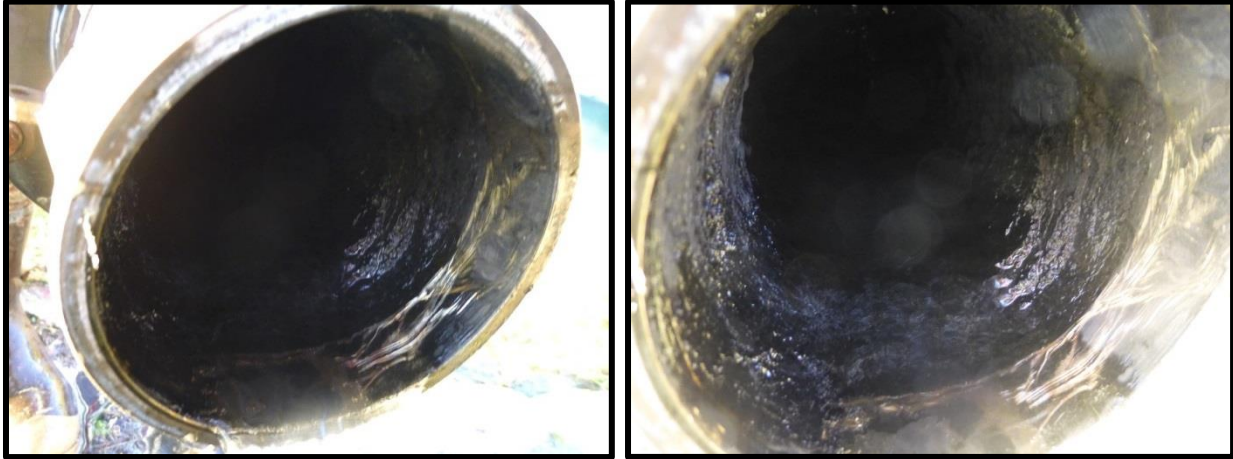
First inspection - October 23, 2013

One week after the *HydroFLOW* 120i was installed - The scale was much softer and easily removed with a knife. A ring was cleaned in order to determine if scale will not accumulate on a clean surface as long as the 120i is in operation.

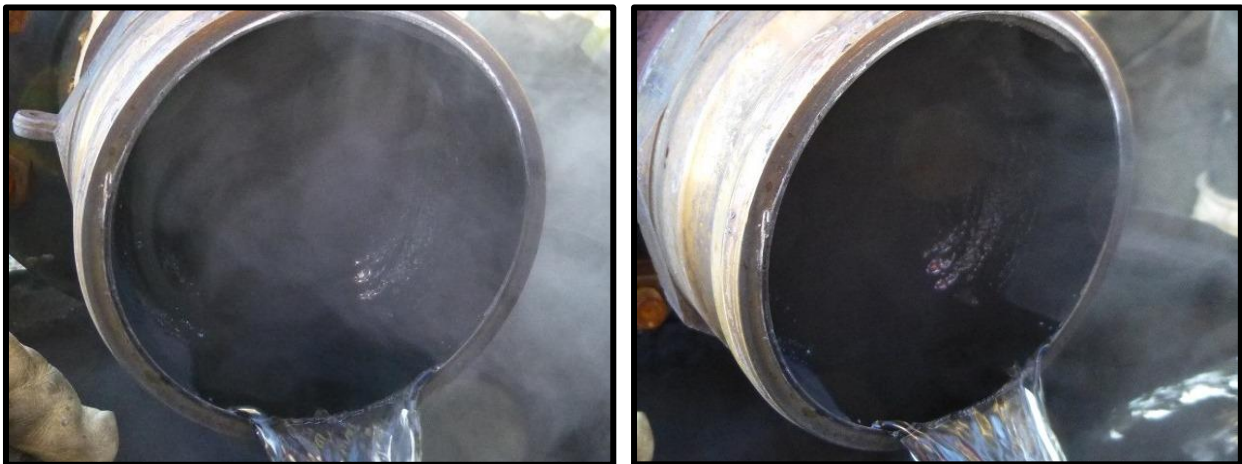
Second inspection - November 18, 2013

One month after the *HydroFLOW* 120i was installed - Apart for what seems like a thin magnetite layer, hard scale is not accumulating on the area that was cleaned after the first inspection. Existing scale can be flaked off with a finger and is roughly 1/8" to 1/4" thick. The customer's personnel were very surprised because typically removal of scale involves hard manual labor.

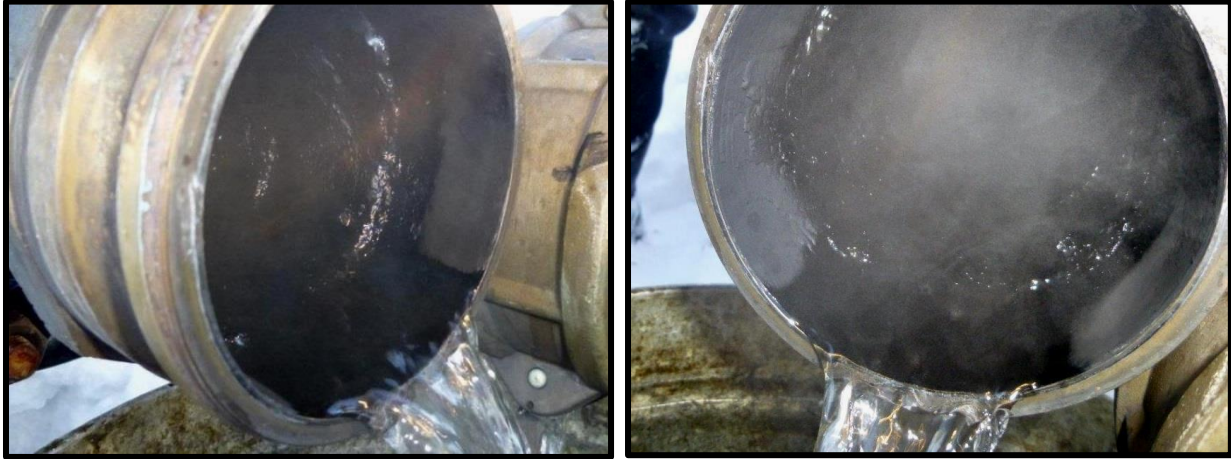
Third inspection - December 30, 2013

Two months after the *HydroFLOW* 120i was installed - Hard scale is not accumulating on the area that was cleaned after the first inspection. Existing scale can be easily flaked off.

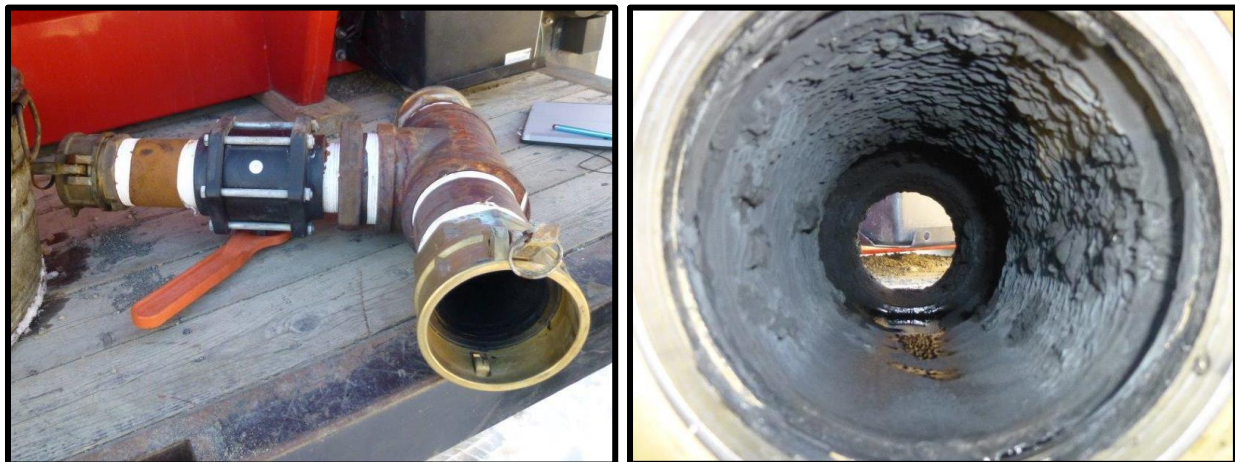
Third inspection - Additional observation

A "T" section was removed from the main line in order to inspect the inside of the pipe. It was noticed that the rate of scale removal from the bottom was much faster than the top and sides. The reason for this is because the bottom of the pipe has constant flow of water which allows scale to be removed more efficiently.
