Case Study - 600 and 700 HP Steam Boilers - Scale

Case study updated on June 10, 2013

Application: 600 and 700 horse power low pressure diesel steam boilers.

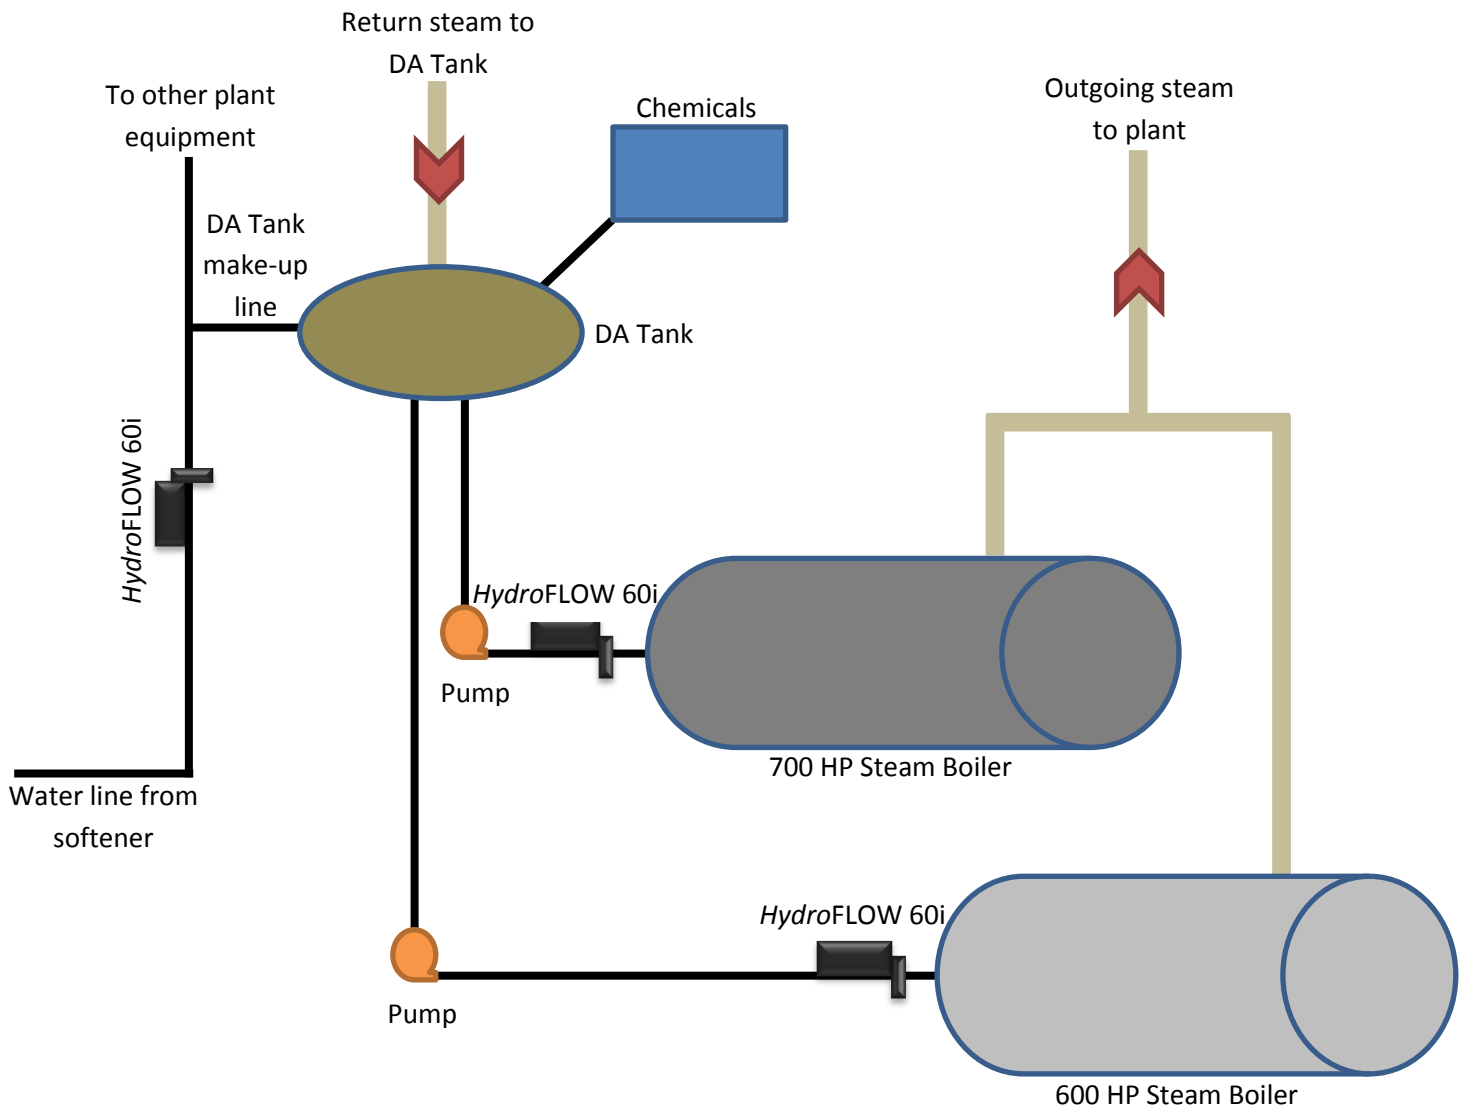
System Configuration

Installed units: One *HydroFLOW* 60i unit was installed on the water line, after the softener, which provides make-up water to the DA tank. Two *HydroFLOW* 60i units were installed on the incoming water line feeding each steam boiler.

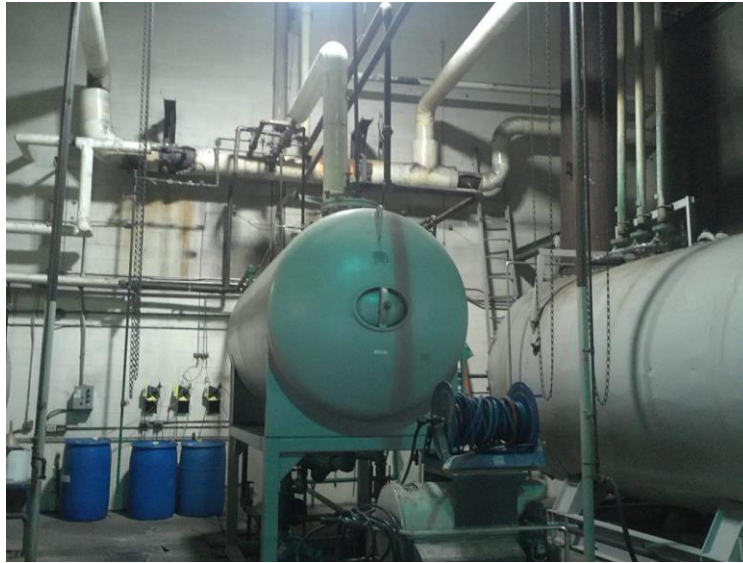
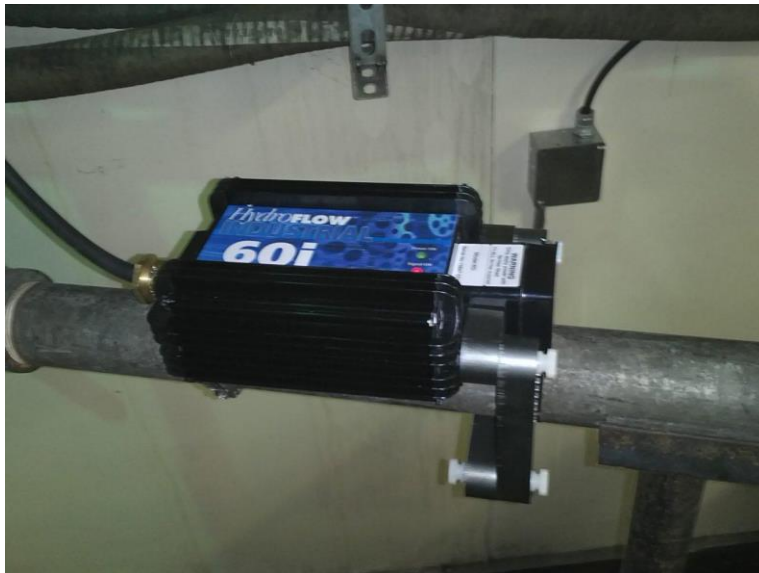
DA Tank

HydroFLOW 60i on water line from softener

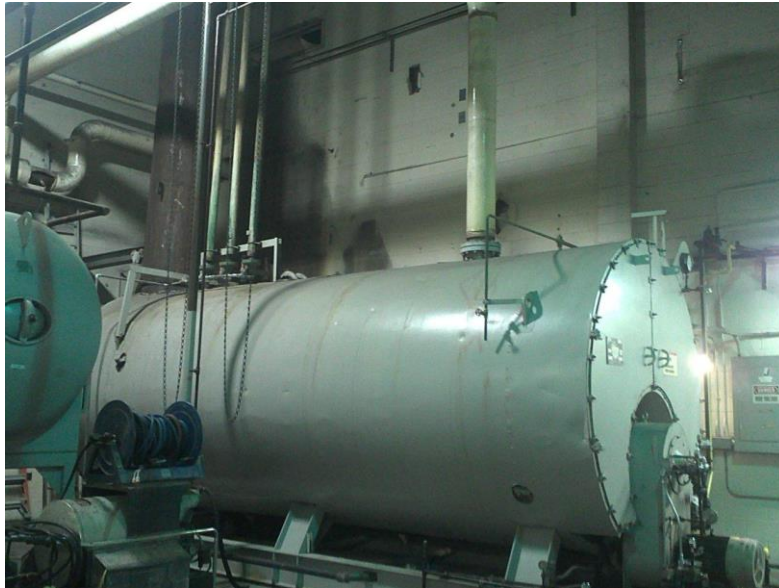
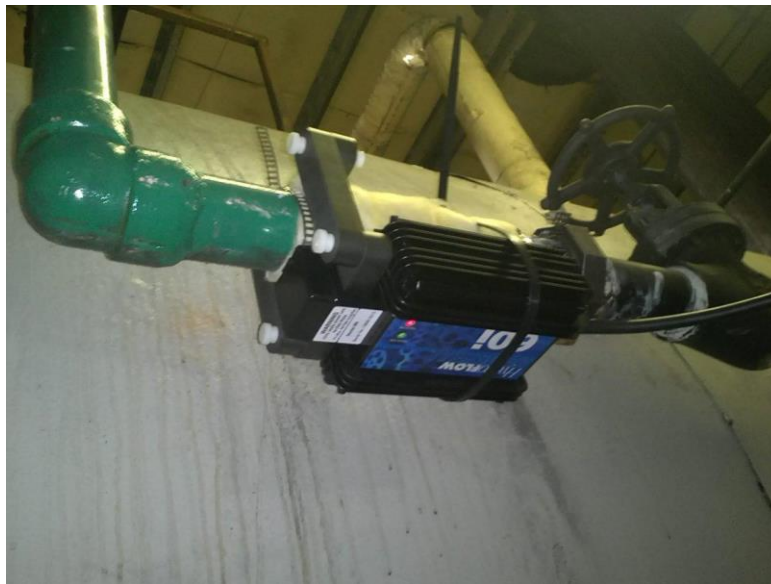
600 HP Steam Boiler

HydroFLOW 60i on pipe feeding the steam boiler

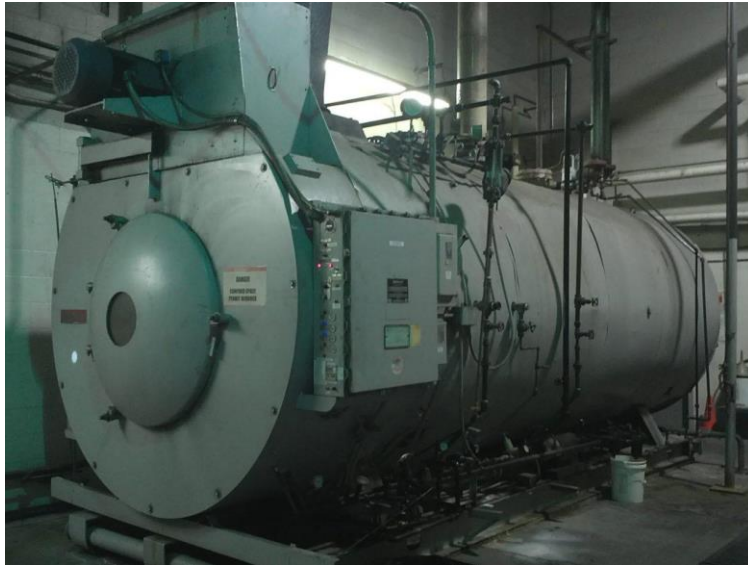
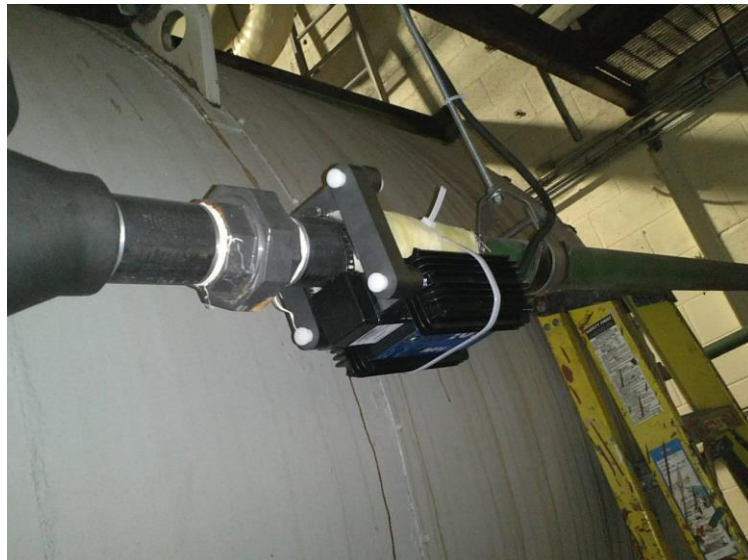
700 HP Steam Boiler

HydroFLOW 60i on pipe feeding the steam boiler

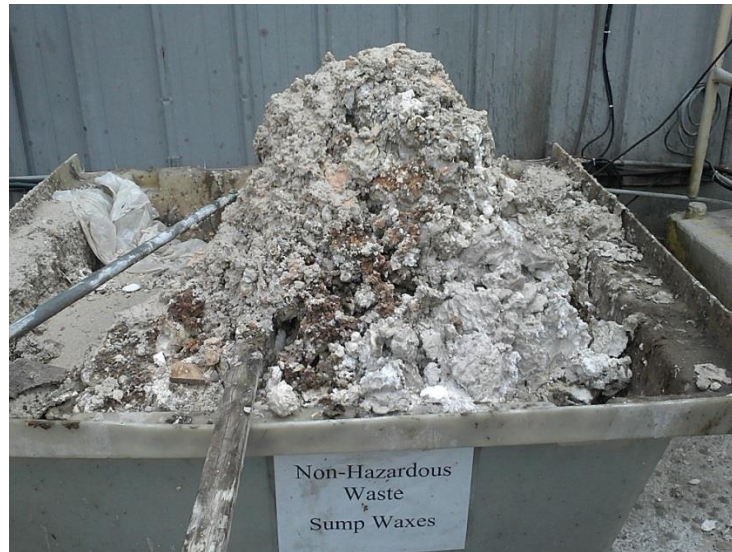
Lime scale from steam boiler blow-down

- Within a few days, soft chunks of grayish and reddish scale and “putty” (wet calcite crystals) began washing out via blow-down.
- Immediately following installation and after consulting with the manufacturer of the steam boilers; the maintenance supervisor increased blow-down frequency to every two hours for the initial 2.5 months. Increasing the blow-down frequency accelerated the removal of scale deposits from the system. Currently, the steam boilers are being blown-down 3 times a day.
