## **Case Study - Hotel Cooling Tower - Scale and Bio**

## Commercial cooling Tower Case Study - 90 Day Evaluation

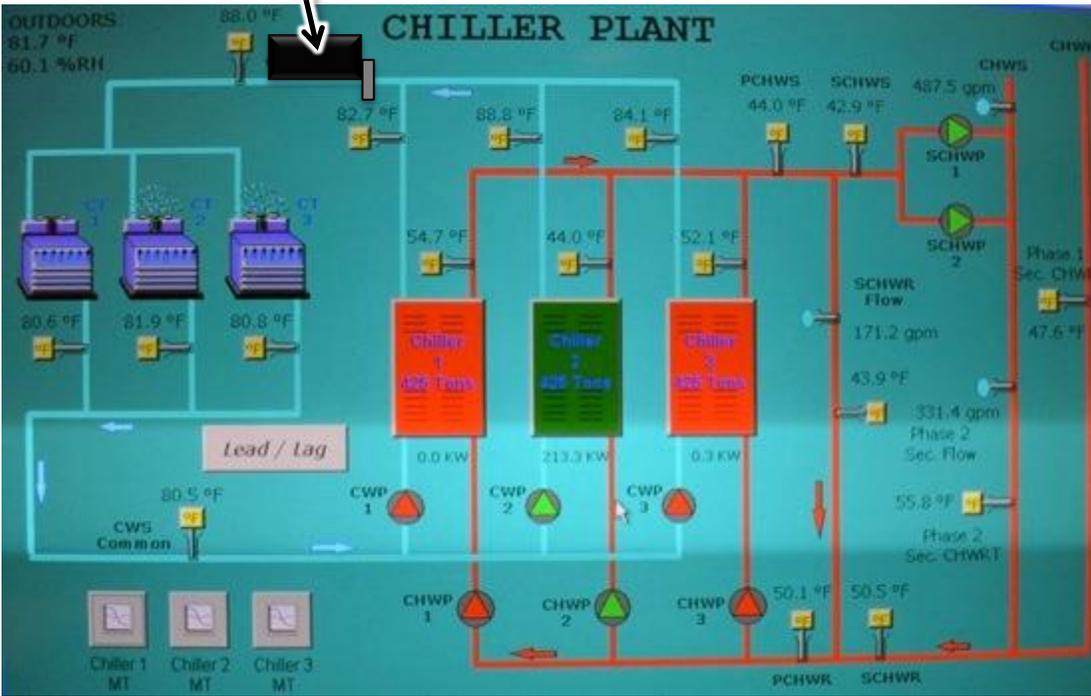
**System diagram and installation point:**

HydroFLOW water conditioner

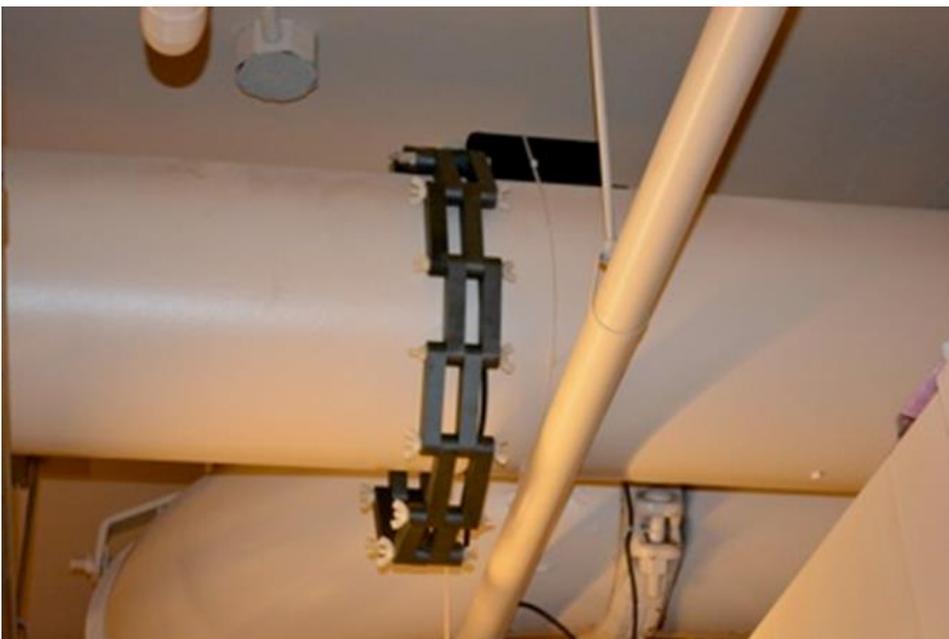
**Installed HydroFLOW water conditioner:**

*HydroFLOW* Custom 14" water conditioner on a cast iron pipe feeding the chillers.

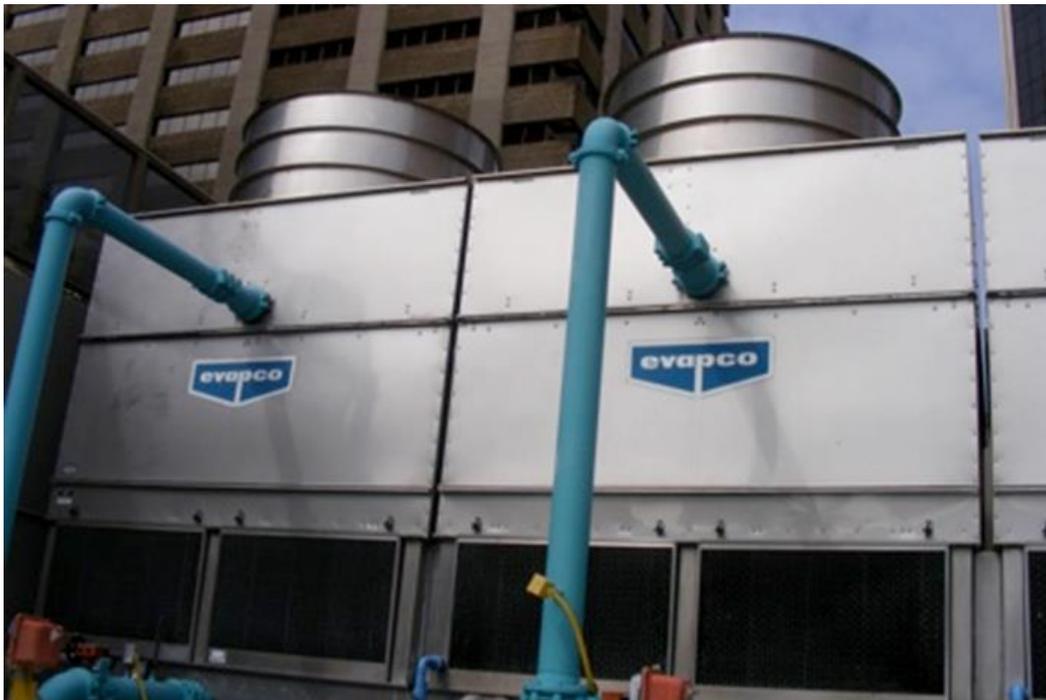
### Cooling Tower Cells

**Installer:** HydroFLOW Master Distributor in Hawaii.  
**Customer:** Central Pacific Plaza  
**Location:** Honolulu, Hawaii - USA  
**Application:** Two 300 ton cells and one 75 ton cell - One 300 ton cell operates during the day, one 300 ton cell is on standby and the 75 ton cells operates during the night  
**Unit:** HydroFLOW 14" Custom on a 12.78" Outer Diameter Cast Iron Pipe  
**Goal:** Keep biological growth, scale accumulation and corrosion rate under control while using minimal amounts of chemicals  
**Timeframe:** Trial began on January 22, 2013 and ended on April 22, 2013

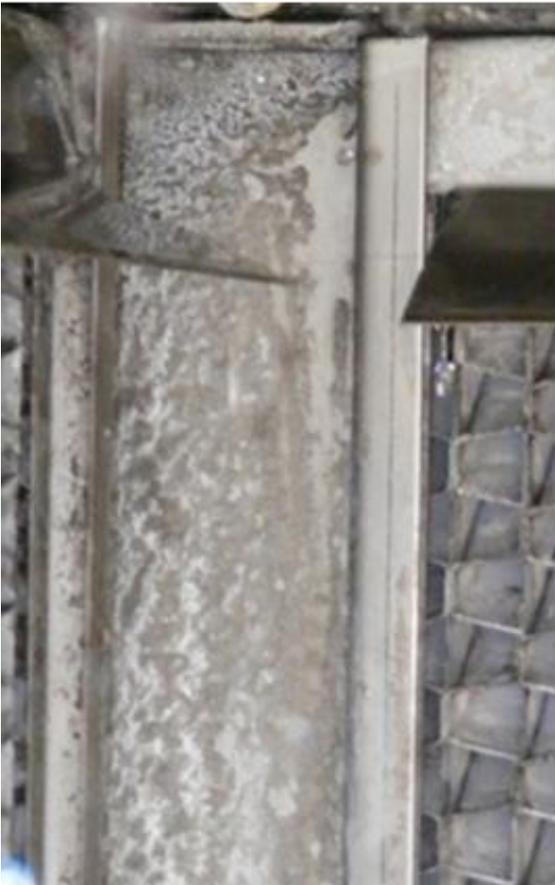
**Before**

Lime scale and corrosion buildup remained under control even though anti-scalant and anti-corrosive chemicals were discontinued

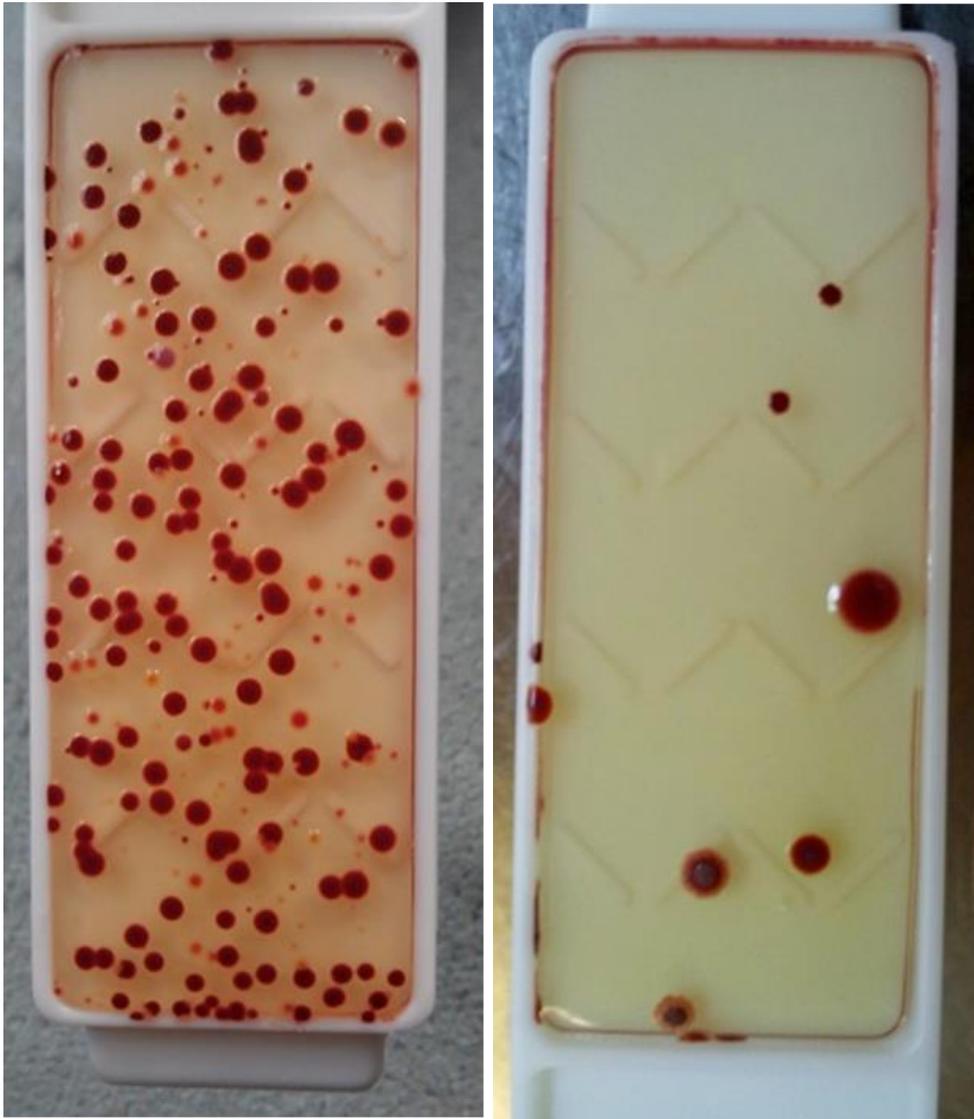
[Dip slides were used to monitor biological count]

Biocide chemical was reduced by 85% and bacteria levels reduced from 100,000 CFU to 1,000 CFU
