Struvite Control Demonstration

at the City of Tulsa Southside Wastewater Treatment Plant

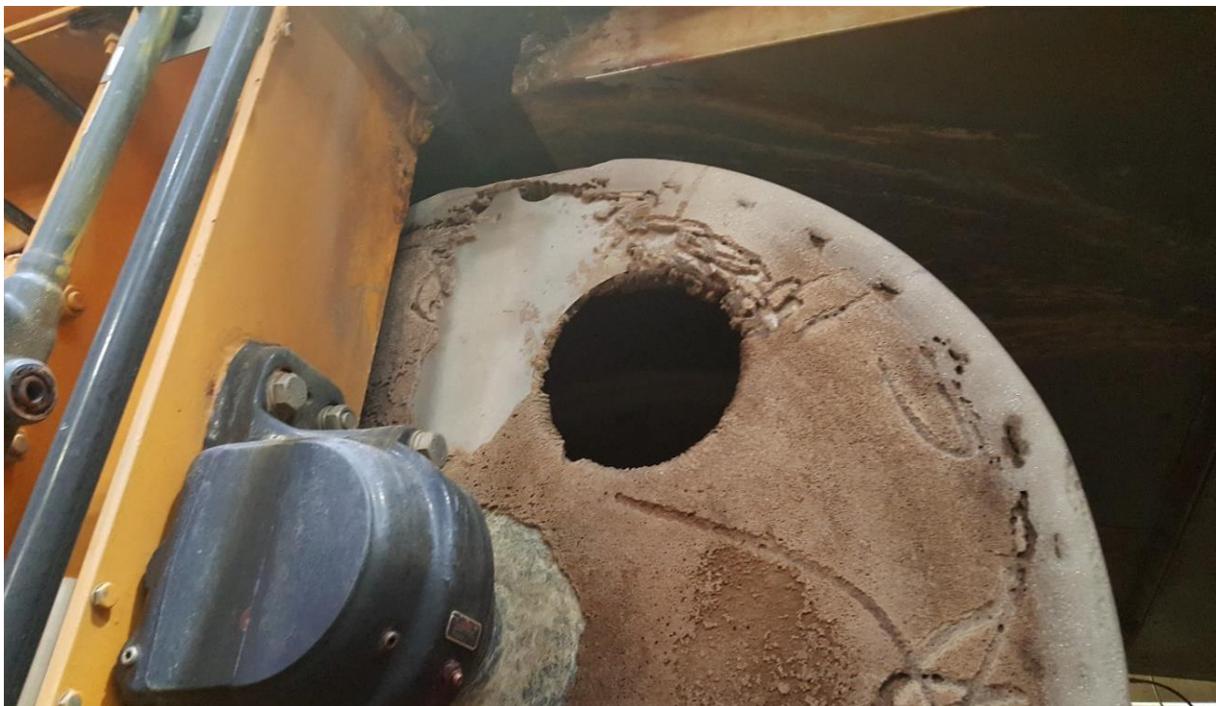
The thin lines seen in the struvite on the picture below [Image 1] are a result of the high pressure washing. The larger area with bare metal was cleaned by this method in advance of the HydroFLOW installation as a control area for verification whether new struvite accumulated while testing the HydroFlow physical water conditioner.

Image 1 – Struvite Removed in Areas Prior to HydroFLOW Installation

The Southside Wastewater Treatment Plant in Tulsa, Oklahoma has been battling struvite scale buildup on each of five belt filter presses. Scale removal is required frequently and is very labor intensive. The process of removing struvite accumulation involves the use of a 3,500psi pressure washer with a zero-degree tip, applying narrow passes to loosen and remove bits of scale at a time.

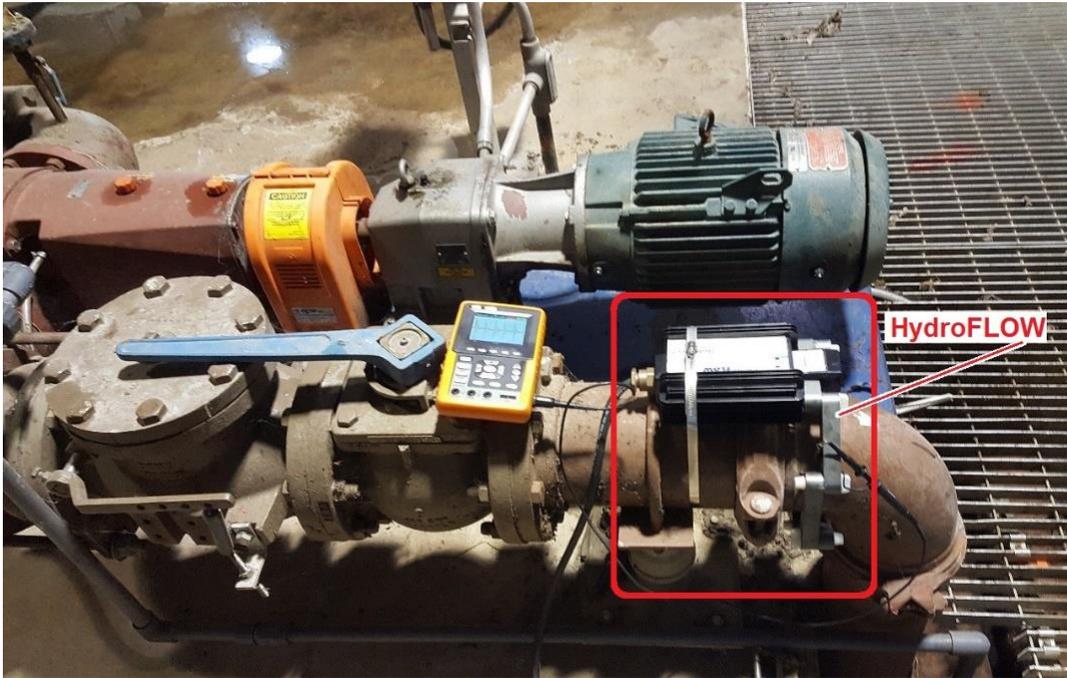
A three-month demonstration trial of the HydroFLOW was started on February 17, 2017. The device was installed around the outside of a 6" ductile iron line [Image 2] that feeds anaerobically digested sludge into one of the belt filter presses. No pipes were drilled or cut during the installation.

Image 2 – HydroFLOW Installed February 17, 2017

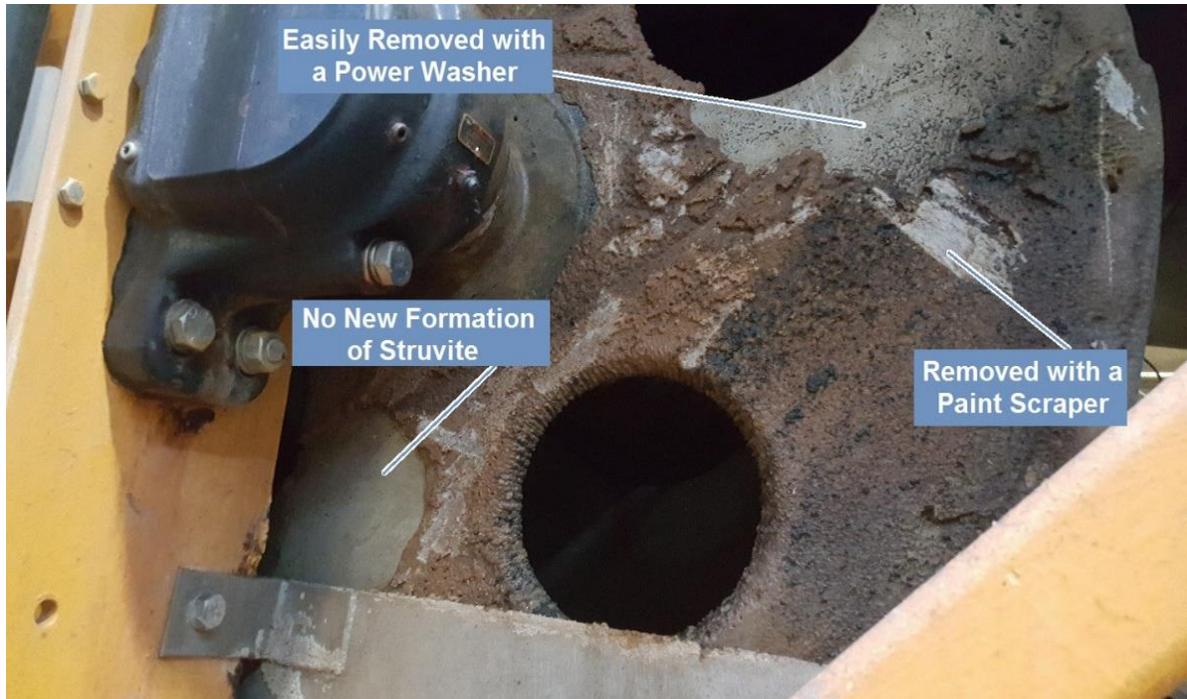
The HydroFlow operated continuously from February 17, 2017 until the conclusion of the test on May 31, 2017. At the end of the test the struvite had noticeably thinned in some areas. Also, some areas could be scraped to bare metal with a paint scraper. When the power washer was used in the same manner as before the test, pieces of scale 3-4" in diameter came off with significant ease of removal than before.

The areas of the press that been cleaned to bare metal before the test showed no signs of new struvite formation. Due to upcoming construction in the Dewatering Facility, the device was removed after the 3-month test period.

Image 3 – *HydroFLOW has Prevented New Struvite and Caused Easy Removal of Existing Struvite*

After the construction has been completed, the Southside plant hopes to install another HydroFlow and operate the device for a longer period and continue to monitor how it performs on struvite. Based on the positive results of the 3-month test the device shows promise and performed as advertised.
